Controle de infecção em serviços de radiologia

Mirian de Freitas Dal Ben Corradi

CCIH- Hospital Sírio Libanês

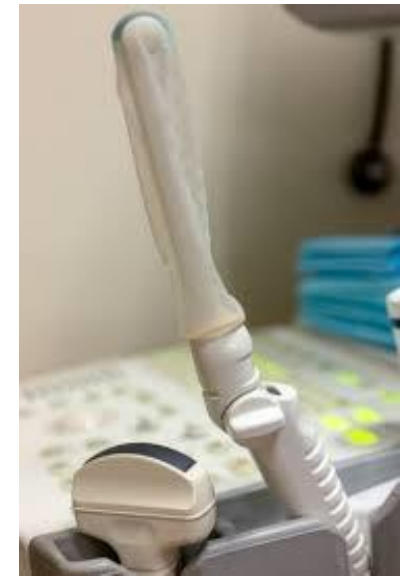
Figure 1. A, Anatomy of the male genitourinary tract in relation to transrectal ultrasound-guided prostate biopsy. C, prostate Winslow. B, Typical biopsy apparatus consisting of ultrasound probe with a protective condom (gray handle) and eagle handle.

Figure 1. *A*, Anatomy of the male genitourinary tract in relation to transrectal ultrasound-guided prostate biopsy. Graphic used with permission of Terese Winslow. *B*, Typical biopsy apparatus consisting of ultrasound probe with a protective condom (gray handle) and spring-loaded sampling device (beige handle).

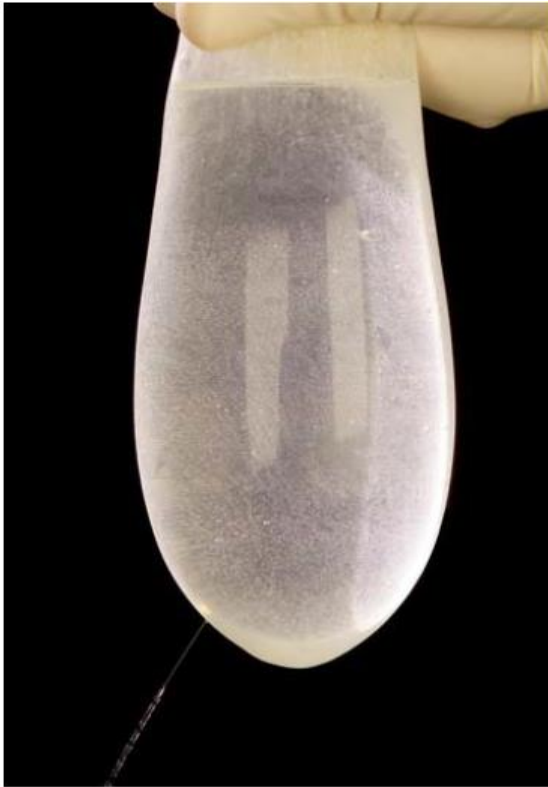
Fig. 2 A water-filled condom demonstrating a perforation caused during the procedure

We have demonstrated a significant condom perforation rate (9%) amongst patients undergoing prostate biopsies. This raises the serious issue of hygiene and

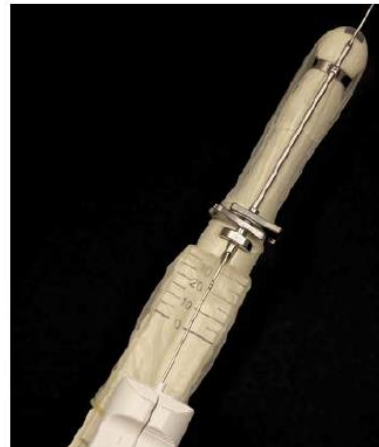
Fig. 1 A standard trans-rectal ultrasound probe with externally attached biopsy apparatus

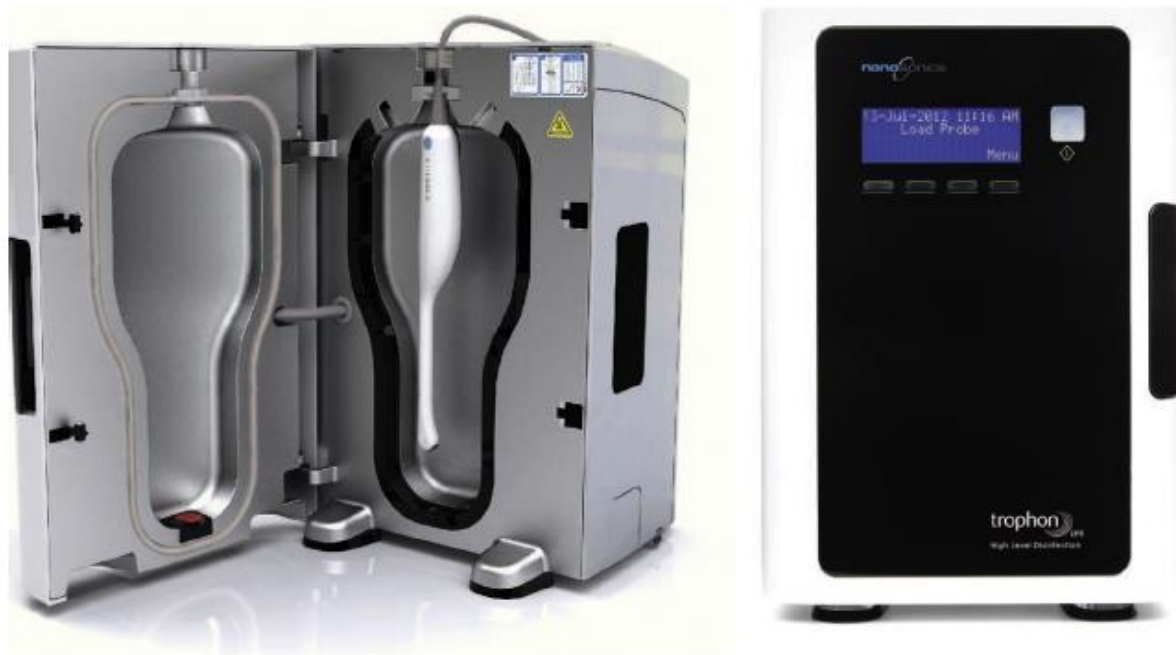
Figure 1 The ultrasound transducer disinfection device tested in this study (Trophon® EPR). This device uses hydrogen peroxide to disinfect ultrasound transducers in an automated cycle.

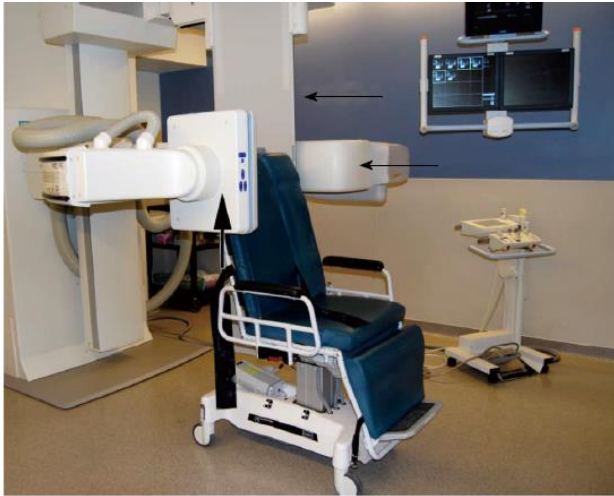
Figure 1 Siemens artis fluoroscopy suite. The table is set up for an upper gastrointestinal (GI) study. Note the relationship of the image intensifier to the table (arrows). The most likely cause of the infections was contamination of the image intensifier and fluoroscopy table during these studies with inadequate cleaning of the suite between GI procedures and arthrograms.

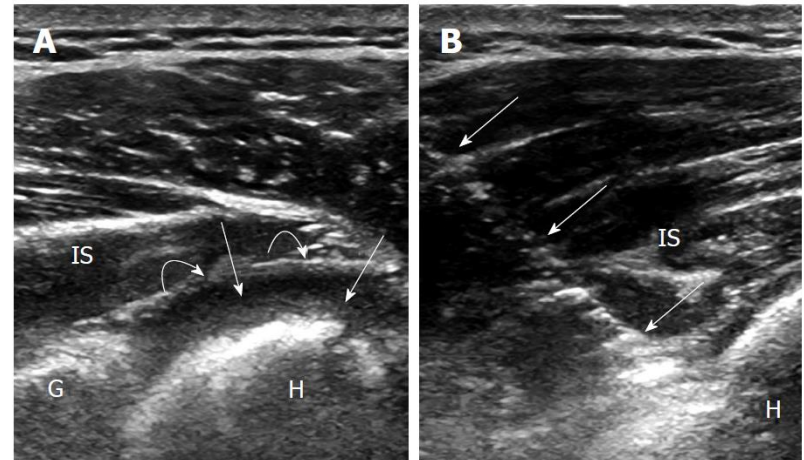
Figure 2 Ultrasound image through the posterior shoulder. A: Axial ultrasound image through the posterior shoulder shows a large joint effusion (straight arrows) with fluid between the humeral head (H) and the adjacent posterior capsule (curved arrows); B: Ultrasound guided aspiration of the posterior shoulder. Note the needle (arrows). Cultures grew *Streptococcus crista*. IS: infraspinatus; G: Posterior glenoid.
